# BELZONA REPAIRS MORE THAN 300 SPALLED CONCRETE LOCATIONS

ID: 6347

Large office building with associated car park.

Office building, Manchester, UK

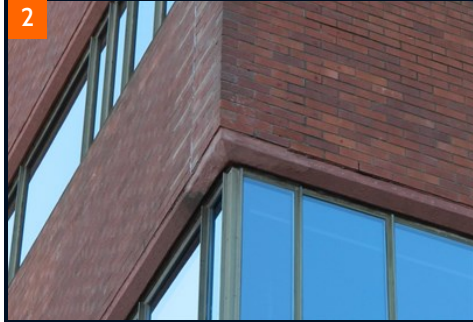
Chunks of concrete were falling from various cracked and spalled areas of the building façade, causing concern for the public below.

1. Deteriorated overhead lintel 2. Lintel rebuilt with colour matched Belzona 4141 3. Spalled overhead concrete 4. Overhead concrete repairs in progress
