# BELZONA PROVIDES ABRASION RESISTANT PROTECTION FOR SCREW CONVEYOR

ID: 6349

The screw conveyor at a water treatment plant was suffering from significant metal loss.

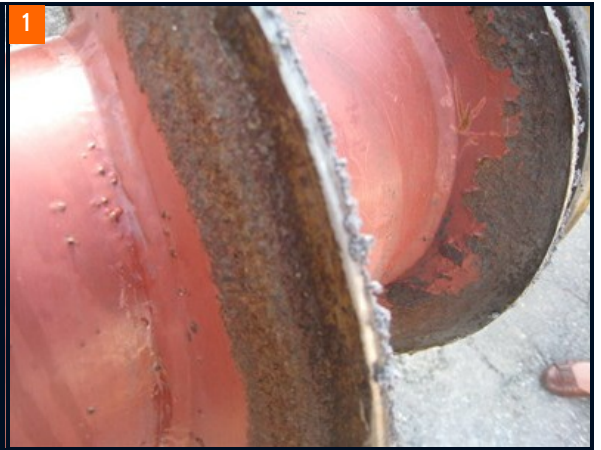
As part of its operation in a treatment plant's slurry clarifier, the screw conveyor was transporting dehydrated slurries. The hard particles in the slurry were causing abrasion of the conveyor blades.

1. Screw conveyor affected by erosion corrosion 2. Metal loss on the blades 3. Belzona 1812 applied 4. Equipment life extended with Belzona protection

Application was carried out in accordance with Belzona System Leaflet SHM-14. After gritblasting Belzona 1812 was applied to the blades to provide abrasion resistant protection.
