# BELZONA TROUGH REPAIR

ID: 635

Trough used to treat wire in drawing and coating process

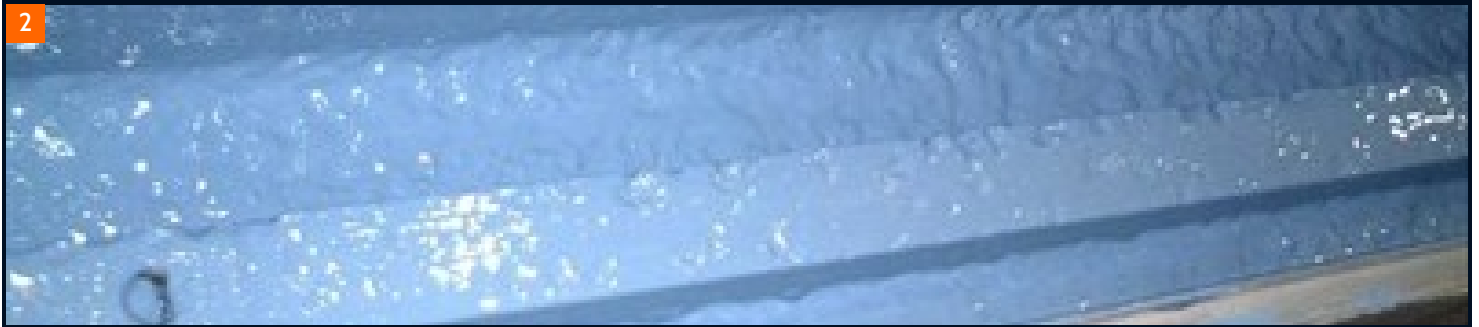
1. The problem
2. The solution

Micro-biological fouling occurring in trough due to temperature and pitting of substrate caused by chemicals used. This was causing health and safety issues and also leaks at joints.

Application was carried out in accordance with Belzona Know-How System Leaflet TCC-5.

Belzona gave a cost effective solution to the problem with the only other alternative being to replace all 320 meters (1050ft) of troughs. System still performing well 3 years on.
