# BELZONA REPAIRS PUMP FOUNDATIONS

ID: 6350

Deteriorated pump foundations

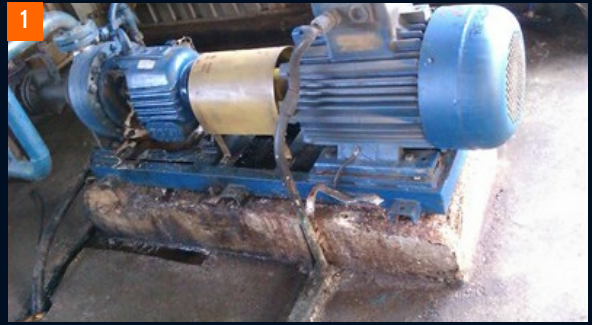
Due to vibration and contact with petroleum products, the foundation of the pump were showing severe deterioration. Cracks were appearing and the holding down bolts were not secure.

1. Pump foundations damaged due to vibration 2. Point of attachment between the pump and pedestal showing signs of deterioration 3. Bolts grouted in place 4. Final repair

Application was carried out in accordance with Belzona System Leaflets FPA-1 and FPA-10. The affected area was cleaned by gritblasting and degreased to remove hydrocarbon contamination. The affected areas were then rebuilt, including grouting in new clamping bolts.
