# BELZONA SEALS WIND FARM TRANSFORMER

ID: 6351

Wind turbine oil filled transformer due for replacement.

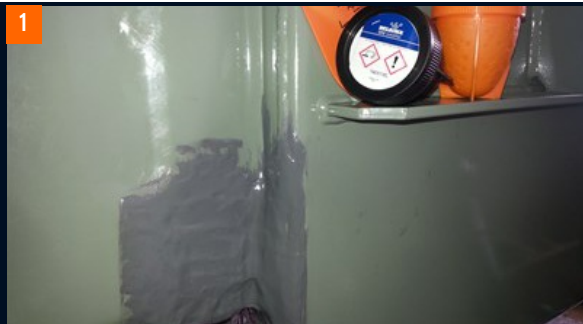
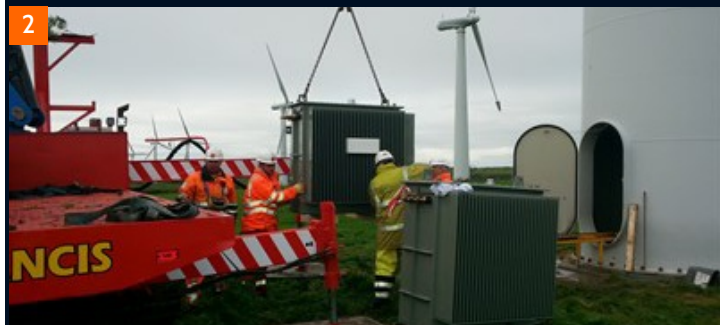
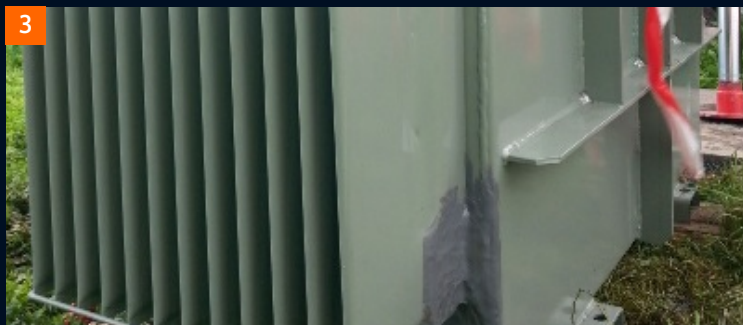
The transformer was leaking transformer oil. This was a safety concern as the transformer could overheat. The transformer could not be transported from site as the leaking oil could contaminate the surrounding farmland. A quick solution was required to avoid operational delays.

The application was carried out in accordance with Belzona KnowHow System Leaflet TCC-1. The surface was prepared using power and hand tools before applying the Belzona 1212 to seal the leak.

Belzona were tasked with supplying material over the weekend as for every day the wind farm was out of service the customer was losing in excess of £34,000 due to the wind turbines were in sequence and all turbines had to be switched out to replace faulty transformers. Belzona 1212 surface tolerant material offered a rapid curing solution to allow the transformers to be replaced as planned with minimum down time and maximum protection to the environment.
