# BELZONA ABRASION RESISTANT LINING FOR DE-BARKER

ID: 6352

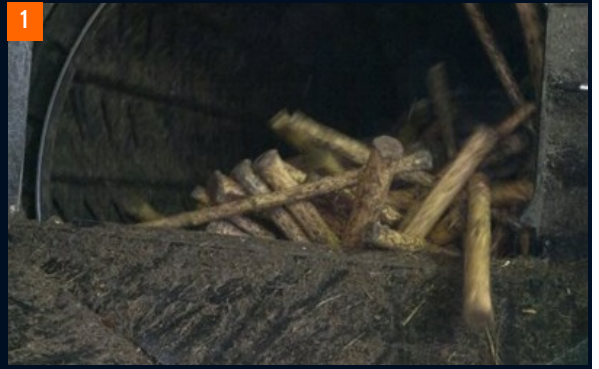
The steel protection plates were wearing away due to severe abrasion. They required a solution to prolong the life of the equipment. If the problem was not resolved during the planned maintenance period, then the customer risked a unscheduled stoppage to the plant and costly downtime.

1. De-barkers create a very abrasive environment 2. Surface preparation prior to application 3. Layers of Belzona 1321 and 1811 applied 4. Belzona 1811 lining of de-barker
