# BELZONA REFURBISHES AND PROTECTS MARINE JET TUBE UNITS

ID: 6354

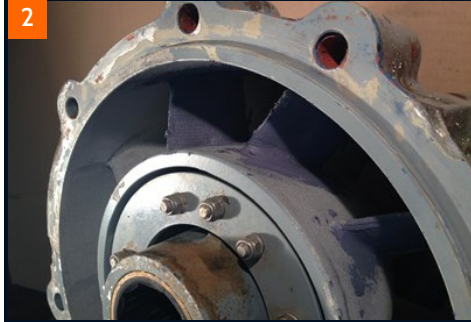
Jet Tubes were subject to cavitation from constant water flow. Since this type of jet tube units is not manufactured anymore, it was critical for the customer to extend the life of the equipment.

1. Blasted surface and visible cavitation
2. Rebuilding the substrate back to its original profile with Belzona 1311.
3. Belzona 1331 being applied.
4. Completed application

After grit blasting and washing the units in a salt away solution to remove embedded salts the units were cleaned with Belzona 9111. Once fully prepped Belzona 1311 was used to fill the cavitated areas, then two coats of Belzona 1331 were brushed on for full protection against further damage.
