# BELZONA SOLVES ACID ATTACK

ID: 636

Sump in chemical plant

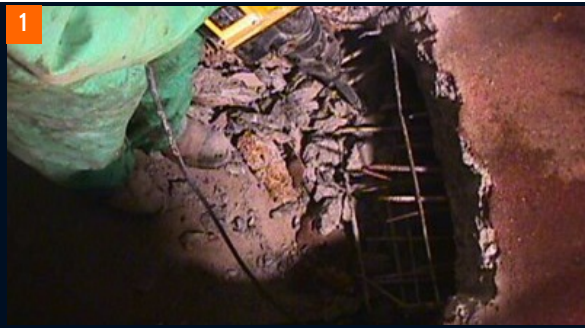
Hydrochloric acid was seeping into a nearby water course. The problem was tracked down to a sump where hydrochloric acid had eaten through the concrete.

After the original insert box was removed the large hole that had been made by the acid eating through the concrete, leaving only remnants of the reinforcing bar was discovered. With the use of heaters, the hole was repaired and sump protected with Belzona within the allowed three-day time frame. Still performing as expected – problem totally solved.

1. The extent of the problem
2. Belzona fills the hole
3. Sump rebuilt
4. Finished application
