# BELZONA WEATHERPROOF PROTECTION FOR INSPECTION BOXES

ID: 6362

Corroded inspection box covers at a National Grid site.

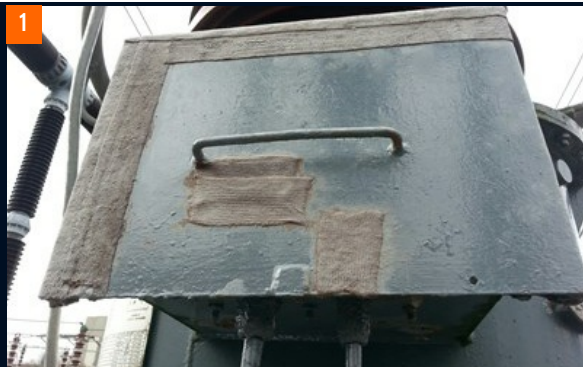
Previous repairs on the boxes had been unsuccessful and close inspection revealed concealed through-wall defects as well as general corrosion damage. The customer wanted a solution that would waterproof the boxes, but could be removed when the switches inside were due for inspection.

1. Corroded inspection box 2. Belzona application in action 3. Completed application 4. System revisited after 8 months

The application was carried out in accordance with Belzona Know-How System Leaflets TCC-1 and GSS-11. Holes were repaired by bonding on small metal plates and other areas of corrosion were rebuilt with Belzona 1111 to allow the cover plate to fit correctly. Belzona 3411 system was then applied to seal the cover plate to provide a water-tight seal.
