# BELZONA RESTORED DOCK STEPS GOOD AS NEW AFTER THREE DECADES

ID: 6368

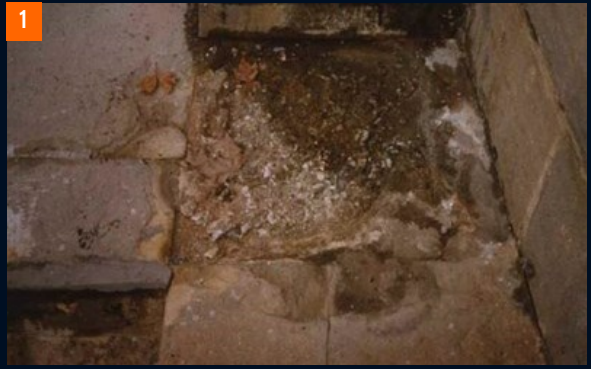
Access steps showed conspicuous signs of deterioration due to the aggressive marine environment and pedestrian traffic from workers over the decades.

1. Deteriorated steps 2. View of the edges during reconstruction 3. Application completed in June 1989 4. View of the same area in September 2016

Application was carried out in accordance with Belzona System Leaflet FPA-1. The damaged area was high-pressure cleaned, manually scarified and rebuilt with Belzona 4111. Belzona 4151 was then applied on top in conjunction with marble chips.

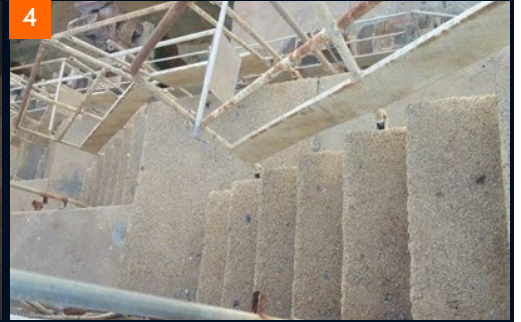
Repair was performed in 1989 and was then inspected in September 2016. After 27 years of service the repaired steps showed no sign of degradation and were in perfect working order.
