# BELZONA PROTECTS NEW BUILT WATER FILTERS

ID: 6369

Internal coating of three water debris filters

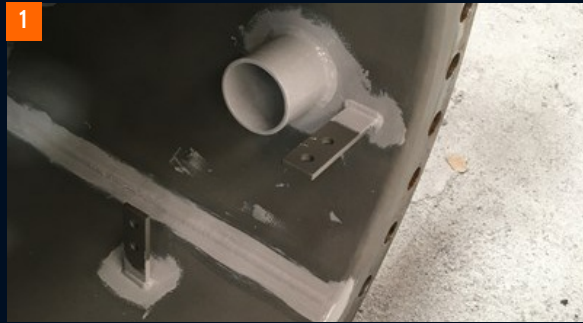
1. Stripe coating with Belzona 1391T
2. First coat of Belzona 1391T applied
3. The three filters fully protected with 2nd coat of Belzona 1391T

The application was carried out in accordance with Belzona Know-How-System Leaflet TCC-5.
