# BELZONA CHANGES THE SHAPE OF COLD PLATE BONDING

ID: 6371

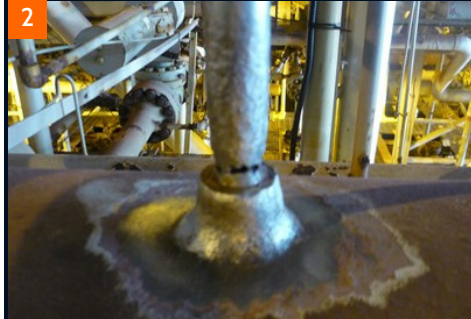
The customer had a 1" inlet into a 20" flare line. The threads of the 1" pipe were corroded and holed through. Any gas leaking out would be a major safety hazard.

1. Corroded inlet before the repair.
2. Inlet after surface preparation.
3. Test fit of plate bonding.
4. Completed cold plate bonding.

The application was carried out in accordance with Belzona Know-How System Leaflet FBC-6 for sealing leaks. Application was carried out by scaffolding up to the pipe rack. Surface preparation included Bristle Blasting. 1"-3" reducer was suggested by the contractor and split in half beforehand. Hose clamps were used to hold the repair until fully cured.
