# BELZONA COLD PLATE BONDING REINFORCES OFFSHORE DECK

ID: 6372

Offshore platform had deck areas with 60% metal wall loss

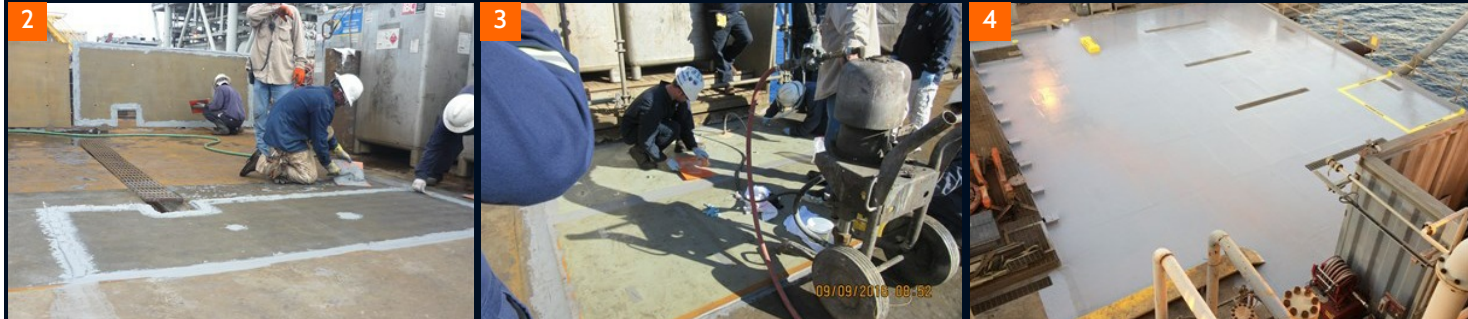
## PHOTOS

1. Pitted and corroded deck.
2. Preparing deck and repair plate with border of Belzona 1121
3. Injecting Belzona 5811 (Immersion Grade) between repair plate and deck.
4. Completed application.

The application was carried out in accordance with Belzona BEL-CIS-100 Creating Irregular Shims and Method Statement for Cold Plate Bonding. All holes on deck were first repaired, then a perimeter bond was created with Belzona 1121. After Belzona 1121 was allowed to cure, Belzona 5811 was injected by single component airless spray into the dam created between the deck and repair plate.
