# BELZONA COLD PLATE BONDING ELIMINATES TRIP HAZARDS ON OFFSHORE DECK

ID: 6373

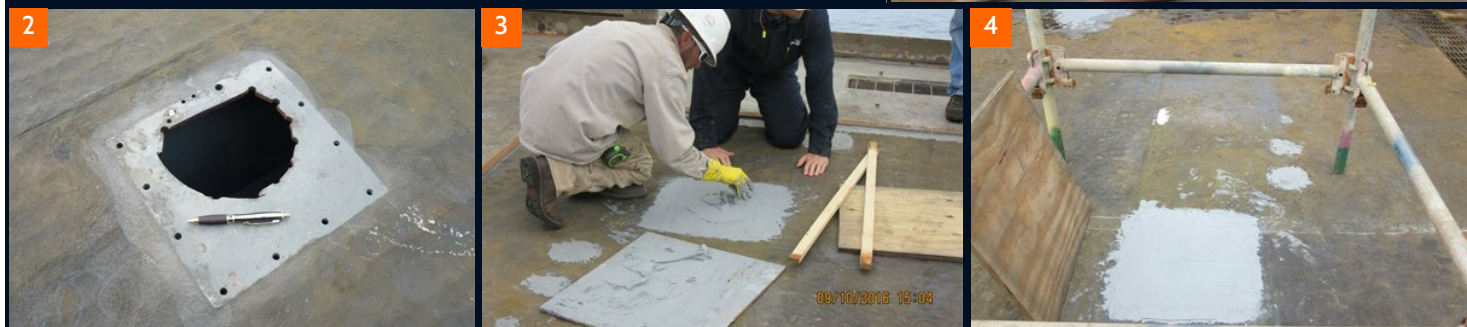
## PHOTOS

The Customer changed some equipment on their platform which required piping through an existing deck. Without a nearby penetration, the Customer cut large holes for this temporary equipment and later repaired them with bolted panels. The panels and bolts were raised nearly  $\frac{3}{4}$ " above the deck surface creating a trip hazard.

1. Trip hazard plate being removed.
2. Surface prepared to near white metal.
3. Applying 1121/9341 composite repair.
4. Completed Application

The application was carried out in accordance with Belzona Know How System Leaflet FBC-6 for sealing leaks and Belzona Cold Plate Bonding.

Belzona 1121 was chosen to repair the deck and not create a raised repair. Due to the hot sun exposure, the deck was 130F during the repairs which further made Belzona 1121 the best choice for the application.
