# REGULATORY AGENCY ACCEPTS BELZONA SUPERWRAP II

Offshore platform with leaking pipe

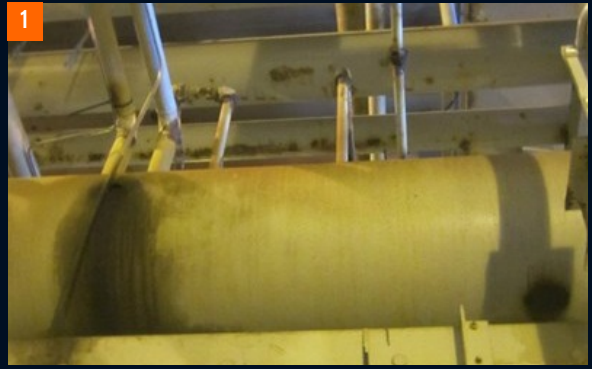
1. Pipe section showing two leaks.
2. One of the hole-through defects.
3. Super Wrap II is applied to nozzles first.
4. Super Wrap II is applied to larger pipe.
