# BELZONA EXTENDS THE LIFE OF A SEAWATER PIPE

ID: 6378

Interior of a seawater piping at an oil producing facility. They were one of the first companies to embrace the new technology of Belzona 1331.

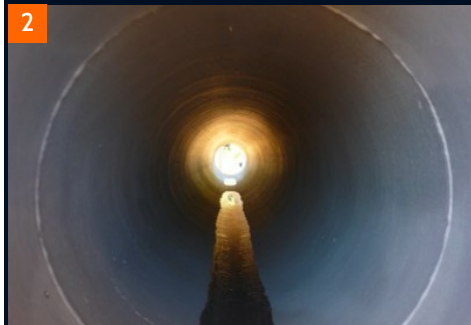
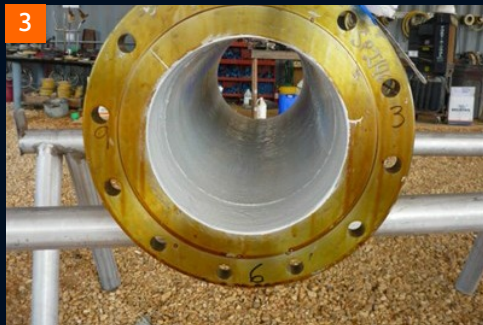
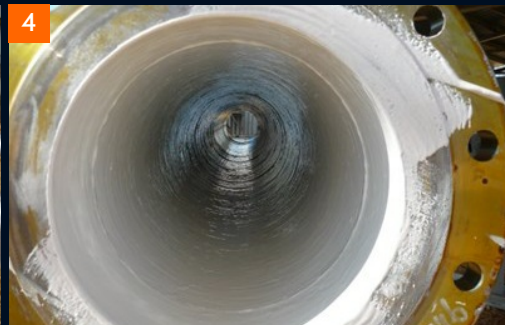
These 12" sections of pipe were internally lined by brush and roller due to spin-spray equipment not available. Belzona 1331 was installed in four thin coats with the pipe orientation changing four times.

1. Pipes after abrasive blasting.
2. Surfaces are degreased prior to application.
3. Belzona 1331 internal lining.
4. Complete application.
