# BELZONA PRESERVES CONCRETE PILES OFFSHORE

ID: 6379

## PROBLEM

At an aging facility off the Louisiana coast, a gas lift station is experiencing fractures in their concrete piles under the foundation. Uneven stress causes some piles to bear more load as weight is transferred off other piles.

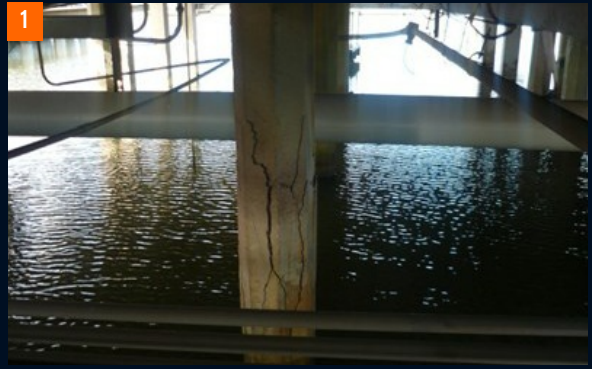
Offshore application. Marshland soil settlement is causing concrete piles to show stress fractures. Exposed rebar is corroding.

1. Fractured concrete pile.
2. Exposed rebar.
3. Pile conditioned with Belzona 4911 and rebuilt with Belzona 4141.
4. Pile encapsulated with Belzona 4151/9371 composite wrap.

Belzona 4141 was used to bulk fill into large cracks and gaps. Belzona 9371 was saturated with Belzona 4151 and used to wrap the rebuilt pile to reinforce.
