# BELZONA 1391 PROTECTS NEW PIPEWORK

ID: 638

New gas scrubber pipework

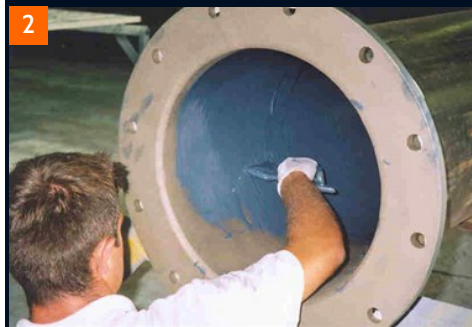
Moisture in the system creates carbonic acid that corrodes the pipework.

1. The problem
2. Application of Belzona 1391
3. Finished job
4. High quality finish clearly visible

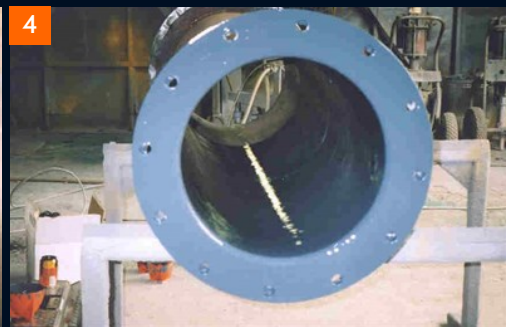
The coating of Belzona® 1391 onto the new carbon steel pipework was chosen over traditional cast iron construction as a more cost effective and long term solution. The application continues to perform as expected.
