# AN OLD STEEL TANK PUT BACK TO SERVICE WITH BELZONA

ID: 6380

A neglected steel oil tank that needed to be put back into service.

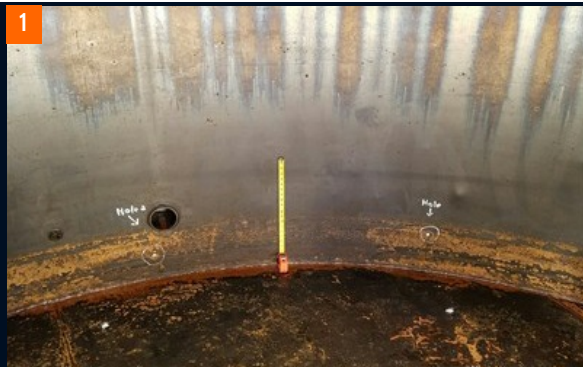
Hundreds of holes in the floor and 8" up walls of the interior of this bulk storage tank. Large holes were visible and straightforward to repair. Small holes and metal porosity plague the entire surface.

1. Hundreds of holes in tank floor and walls.
2. Process of Belzona 1121 composite repair and cold plate bonding on floor.
3. First coat Belzona 5811 Grey
4. Second coat Belzona 5811 Black

Belzona 1121 was used to cold plate bond steel over large holes and incorporated into Belzona 9341 cloth for smaller ones. Two coats of Belzona 5811 was used over all surfaces to seal micro porosity.
