# BELZONA SUPERWRAP II REPAIRS DRAIN LINES ON DEEPWATER PLATFORM

Deepwater platform has 17 areas on drain line that need repair. The repair needed to be ASME compliant.

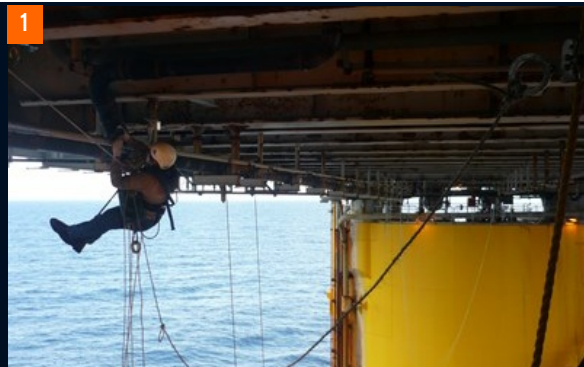
1. Overall view of drain line.
2. Example defect on pipe.
3. Area prepared and Testex profile tape.
4. SuperWrap II installed by rope access.
