# KEEPING AFLOAT WITH BELZONA

ID: 639

Sponson (An air bag or floatation device) attached to a fast rescue craft.

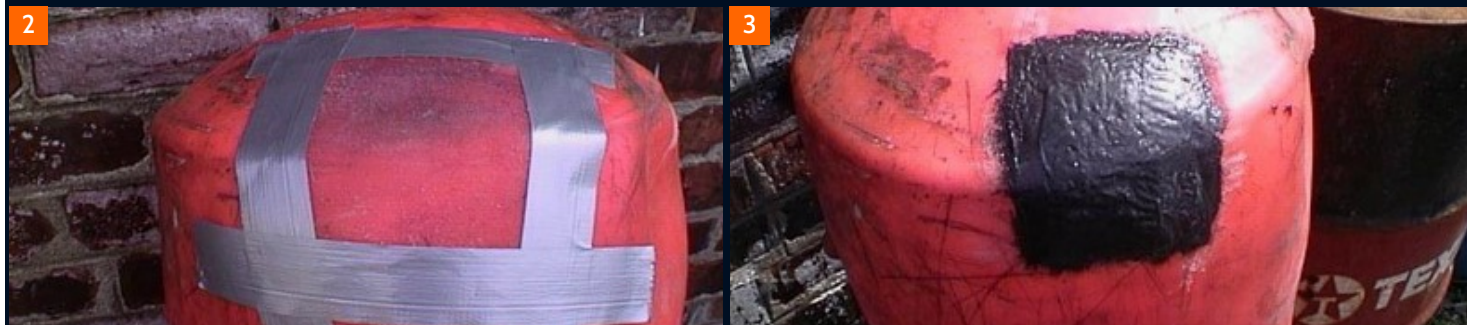
## PHOTOS

Damaged due to collision with other objects such as boats, flotsam etc.

1. Surface prepared
2. Area marked up, ready for the Belzona
3. Finished repair

Application was carried out in accordance with Belzona Know-How System Leaflet SOS-12.

Belzona® 2311 (SR Elastomer)
