# WASTEWATER VACUUM TRUCK INTERNAL COATING AND REPAIR

ID: 6393

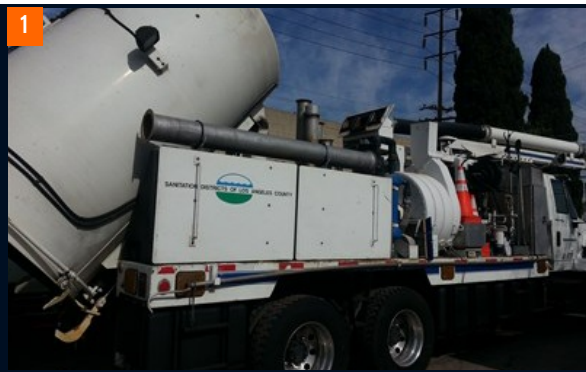
1. External view of the vacuum truck
2. View of the damaged internal area
3. Belzona 1812 applied to the opening/back opening door
4. Belzona 1321 applied to the intake pipework and Belzona 5811 applied to the entire tank

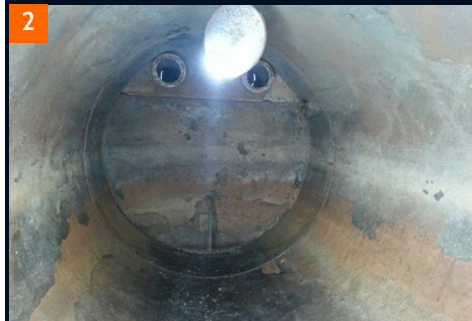
This damage was leading to failures within the intake pipe and corrosion was being found throughout the tank as a whole. If not addressed properly with the correct protection, the tank would eventually run to failure and require replacement.

The wastewater and miscellaneous discharges of sewer compatible wastewater (MISC) were causing the interior of the vacuum trucks of the City of Los Angeles to corrode and become damaged from impact abrasion.
