# FACTORY FLOORS IN FOOD PRODUCTION AREA REPAIRED AND IMPROVED

ID: 6395

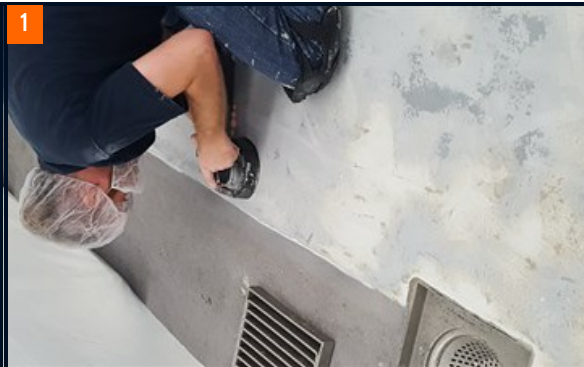
1) Grinding a smooth seam based on the area to be coated 2) Rolling down the Belzona 5231 3) After the Belzona 9221 (aggregate) is broadcasted 4) After application is finished and cured overnight

Surface was shot blast / hand grinded to achieve desired surface profile. Belzona 5231 was applied as a base coat and Belzona 9221 was broadcasted. Belzona 5233 was applied as a top coat.
