# BELZONA PROVIDES LONG-TERM PROTECTION TO A TURBINE'S INLET SCROLL AND BELLMOUTH

ID: 6396

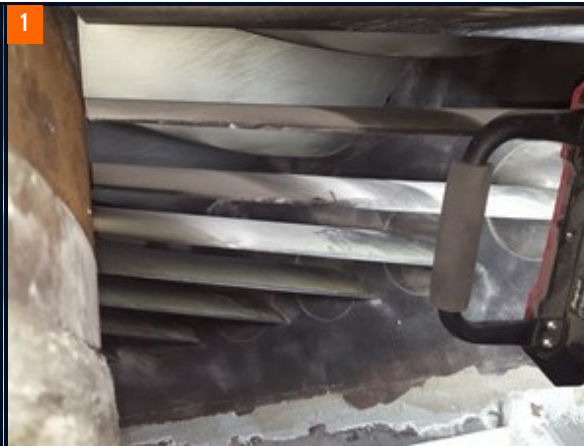
The failing coating provided no protection to the substrate against the environment and could flake off into the turbine. This could potentially lead to catastrophic damage including total shutdown and repairs to the turbine blades in excess of \$200,000.

The inlet scroll and bellmouth of a gas-fed turbine was previously coated with an inadequate coating.

1. Failing coating on the substrate.
2. Blasted substrate.
3. Coated substrate with Belzona 5892.
