# WATER RUNOFF PIT WALLS REPAIRED WITH BELZONA

ID: 6397

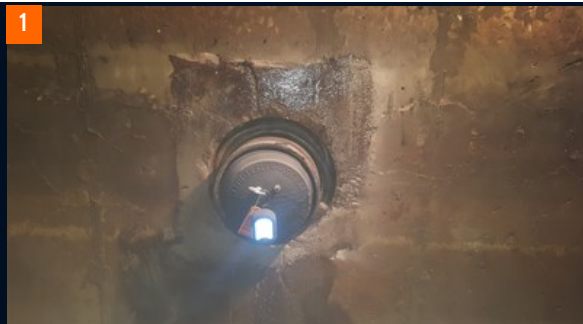
1. Prep Surface
2. Belzona 4131 used to bring back original conditions to wall
3. Belzona 5811 used to seal over repairs
4. Ball Valve Plug used to stop water flow for application

The area around the pipe was hand prep with a grinder to achieve the desired surface profile. Backing rod was pushed into the voids around the pipe to create a backing for the 4131. Finally, Belzona 5811 was applied to seal the repair area.
