# BELZONA PULVERIZER SHAFT

ID: 64

Pulversizer shaft

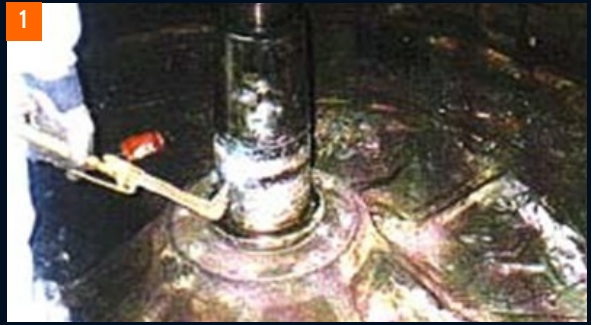
Coal fines work their way underneath the seal fit and cause wear to the shaft.

1. Sweating oils from the substrate.
2. The split-form molding technique is used.
3. Formers removed, Belzona 1311 ready for dressing down.

The application was carried out in accordance with Belzona Know-How Leaflet MPT-2.
