# BELZONA HELPS FIRE PUMP PERFORM AGAIN

ID: 6403

Bronze Fire pump impeller on a US Navy Ship

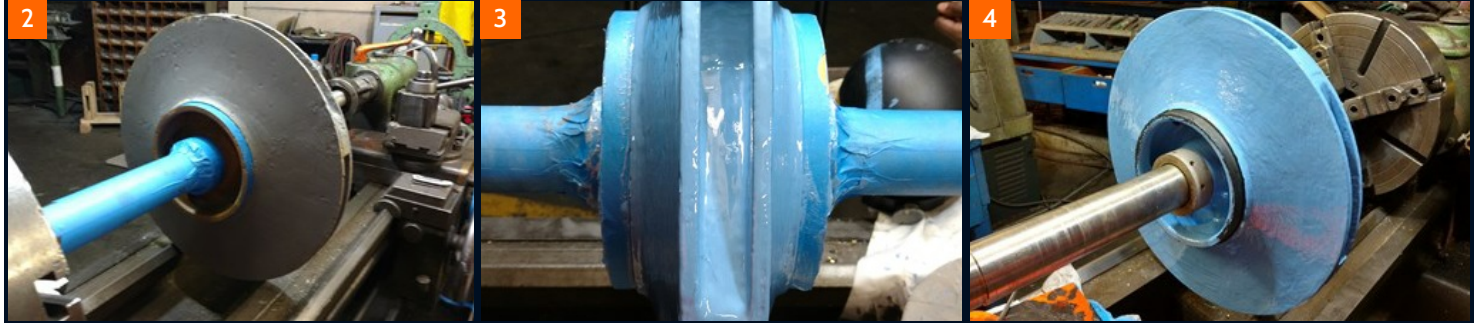
Impeller had suffered heavy cavitation and erosion due to contact with salt water.

1. Bronze pump impeller grit blasted and showing damage.
2. Eroded areas rebuilt with Belzona 1111
3. Impeller coated with Belzona 1341
4. Belzona 1131 applied to wear ring area

The application was carried out in accordance with a modified version of Belzona System Leaflet CEP-3. Cavitated and eroded areas were rebuilt with Belzona 1111. The impeller was then coated with two coats of Belzona 1341 by brush; grey base coat, followed by a blue top coat. Critical wear ring area was rebuilt with Belzona 1131.
