# BELZONA POSITIVE GRIP SYSTEM PROVIDES SAFETY TO WORKERS

ID: 6405

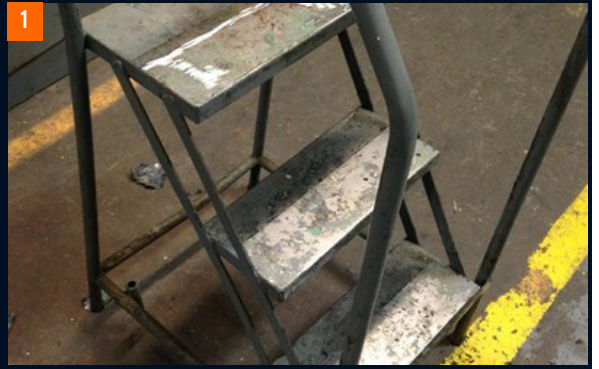
1. Steps prepared for application 2. Application of Belzona 5811 in progress 3. Application of Belzona 5811 and 9211 completed 4. Application revisited two months later, already outperforming the non-slip tape

Application was carried out using Belzona Know-How System Leaflet FPA-8. Steps were cleaned and roughened with an angle grinder. Edges were taped off to create clean lines. First, Belzona 5811 was applied at 20 mils thickness, then Belzona 9211 was added to the point of rejection.
