# BELZONA REPAIRS AND PROTECTS LEAKING TRANSFORMER TURRETS

ID: 6406

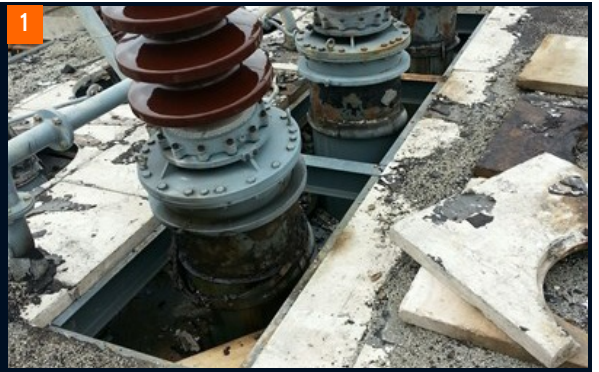
Transformer turrets are normally sealed from the weather into the roof above the transformer. Rainwater had leaked in between the roof & the turret allowing corrosion to take place.

1. Turrets before work commenced 2. Close up of the corrosion on the turrets 3. Plates bonded in place with Belzona 1161 4. Belzona 5831 applied to provide long term corrosion protection

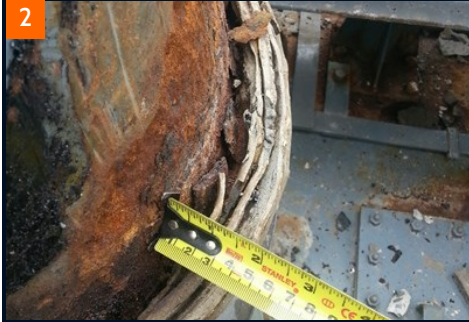
The corrosion had led to a loss of wall thickness. Some of these thinned areas had begun to leak. Loss of oil from the transformer represented a safety & environmental hazard. A fast, long term repair was required to fix the problem. No hot works are allowed due to the presence of oil.
