# BELZONA MAKES QUICK WORK OF CLEAT REPAIR

ID: 6407

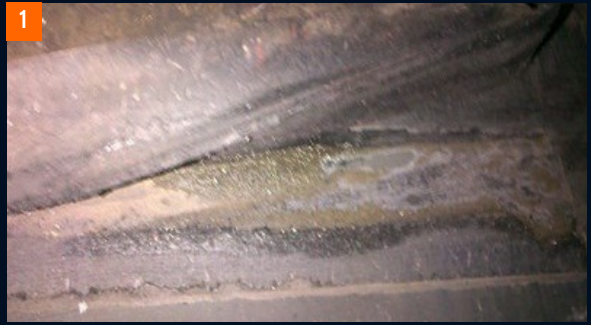
Cleat on conveyor belt used to sort materials at a recycling facility was torn and ineffective. The design of the equipment was allowing the conveyor to become clogged and putting more strain on the cleats than the original vulcanization could handle.

1. Damaged cleat
2. Repair area cleaned, roughened, and conditioned
3. Repair completed
4. Repair revisited 8 months later, still performing perfectly
