# BELZONA SHAFT REPAIR KEEPS THE CONVEYORS TURNING

ID: 6408

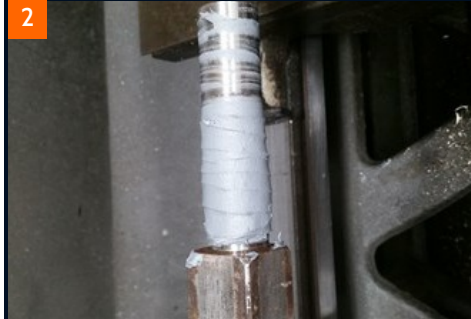
A bearing had overheated and seized resulting in a worn area on the shaft.

1) Shaft undercut and grooved in preparation for application Photo 2) Belzona 1111 build up completed Photo 3) Turning shaft back to original outer diameter Photo 4) Application completed and perfectly fit to a new bearing

Application was carried out in accordance with Belzona System Leaflet MPT-1. Shaft was placed in a lathe and the damaged area was undercut and grooved to aid in mechanical bonding. Final cleaning was done using Belzona 9111 cleaner/degreaser. Belzona 1111 was built up on the shaft, taking care to press it firmly into the grooves and avoid air entrapment. After approximately 90 minutes the shaft was turned on the lathe back to its original outer diameter and polished with emery cloth to create a perfect fit with a new bearing.
