# BELZONA SEPARATES DISSIMILAR METAL PIPES

ID: 641

## PROBLEM

Galvanic corrosion between dissimilar pipe sections.

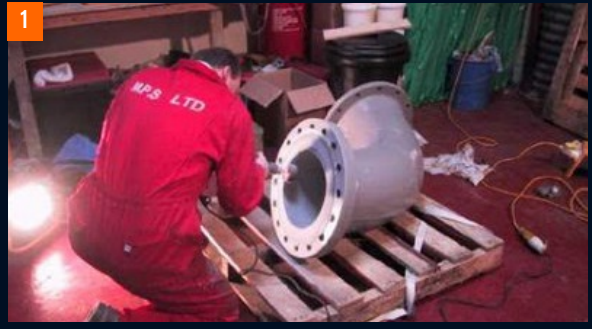
1. Surface Preparation
2. Pipe masked up
3. Finished Application

Application was carried out in accordance with Belzona Know-How System Leaflet VPF-2.

Belzona's electrical isolating properties form a barrier to the electrolytic cell set up by the dissimilar metal thus stopping galvanic corrosion. The previous vulcanized rubber coating had failed in less than 6 months. These repairs were still in service four years later.
