# BELZONA BULKFILL USED ON LOADING BAY

ID: 6417

Asphalt covered loading bay to the plasterboard factory.

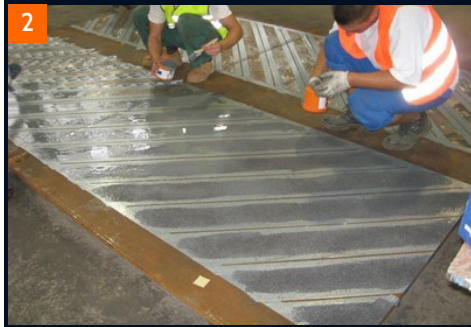
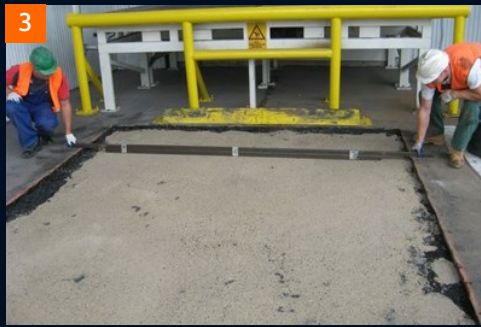
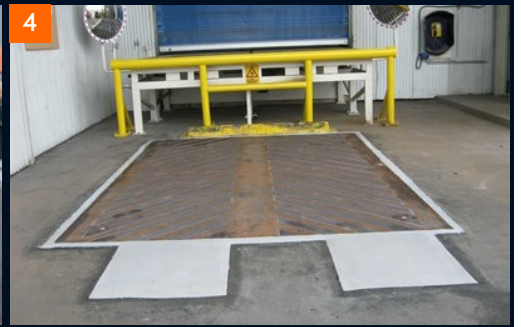
Regular loading and unloading caused severe wear to the surface of the loading bay. A cost effective solution to this ongoing problem was required.

1. Chipping away the existing asphalt 2. Applying Belzona 4411 Grip System to steel plate 3. Applying Belzona 4154 to the large area 4. Completed application

Application was carried out in accordance with Belzona System Leaflets FPA-1, 2 & 8. After chipping away the damaged asphalt with pneumatic tools, the area was cleaned and prepared, followed by Belzona 4154 to bulk out the area. Belzona 4111 was then used to level the surface and to secure steel plates, previously coated with Belzona 4411 grip system.
