# BELZONA IMPROVES SAFETY WITH GRIP SYSTEM

ID: 6418

Factory main entrance steps.

Factory, Kirkop, Malta.

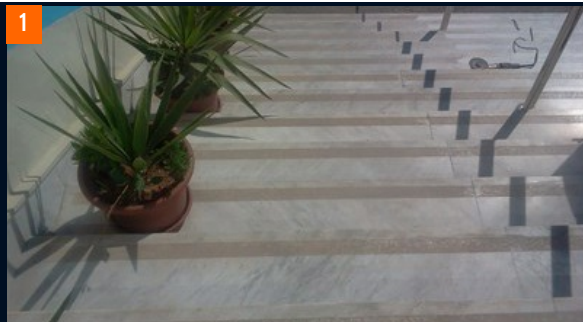
Marble stairs were very slippery, especially in wet conditions.

1. Abraded nosing resulted in a non-effective solution
2. Nosing ground by carbide discs
3. Area Masked off
4. Completed application

The previous solutions of abrading the nose or stick on strips had proved to be ineffective. Belzona 4411 reduced the potential for accidents as well as creating an aesthetically pleasing finish.
