# BELZONA STOPS THAT SINKING FEELING

Floating sand dredger

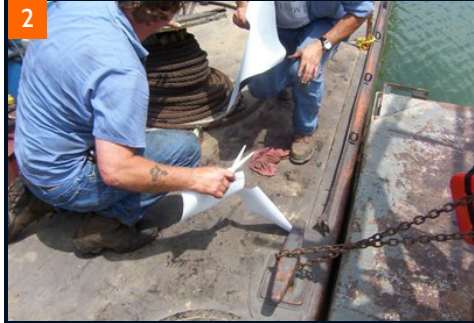
The hull was leaking in several areas of this sand dredge. If the electricity failed when the plant was unattended the vessel could sink into 30 feet of water.

1. Leak in the hull
2. Cutting magnetic sign material
3. Divers positioning signs to stem the leak
4. Leak stopped with Belzona 1111

Application carried out in accordance with Belzona Know-How System Leaflet SOS-20. Divers placed magnetic sign material over the leaks. This stopped the flow of water while the surface crew dried, cleaned and prepared the area. Belzona® 1111 with Belzona® Reinforcement Tape was applied to the area.
