# BELZONA EXTENDS THE LIFE OF SLURRY PUMP CASINGS

ID: 6422

Three casings of Slurry pumps with removable thick rubber protectors at flotation production site.

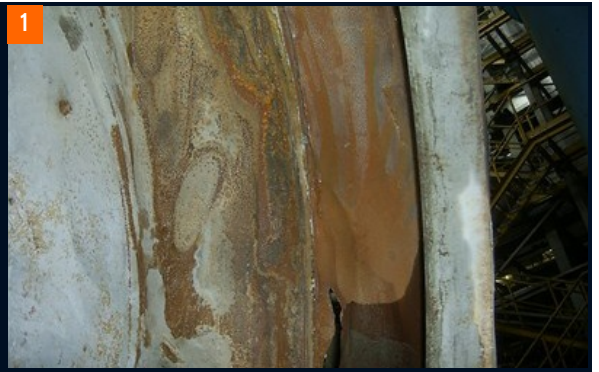
The casings were badly worn, even through the whole thickness in some places.

1. General view of casing before repair
2. Manual preparation of repaired surfaces
3. Application in progress
4. Final view of completed application.

The application was carried out in accordance with Belzona Know-How System Leaflet CEP-5. Surfaces were mechanically abraded. Then all pitting and damage was filled with Belzona 1311 and when cured the surfaces were smoothed by grinding.
