# BELZONA CORROSION PROTECTION FOR CO2 ABSORBER TOWER

ID: 6424

60 metre tall process CO2 absorber tower required corrosion protection

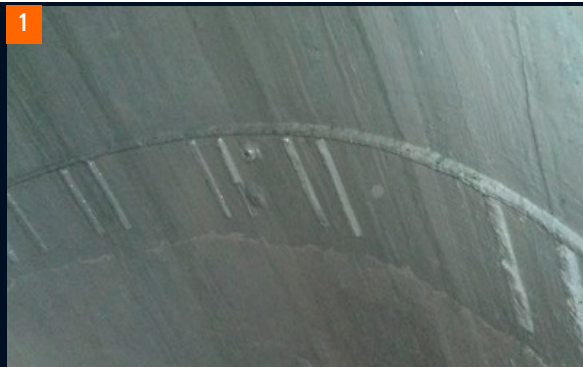
The process tower had worked previously without internal lining until the discovery of major erosion / corrosion defects. The first application of Belzona was carried out in 2014 and the condition was inspected every year. The last inspection in 2016 has reported no degradation of Belzona lining.

1. Inspection in 2016 of the lining applied in 2014
2. View of the pad welded defect areas
3. View of repair with Belzona 1311
4. The final application with Belzona 1391

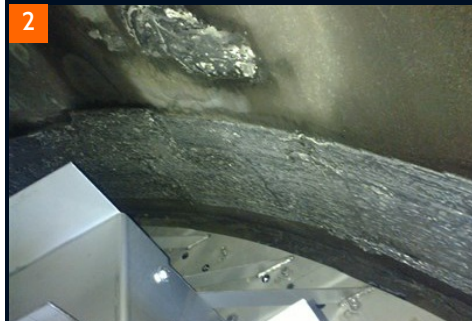
Significant defects of the inner walls and the bottom of the absorber due to corrosion and erosion in the presence of aggressive chemicals such as MDEA & MEA at elevated temperatures (80-100°C).

The applications were carried out in accordance with Belzona Know-How Leaflet TCC-3. The customer pad welded deeply pitted areas. Less damaged areas were filled and smoothed with Belzona 1311 before coating with Belzona 1391.
