# BELZONA REBUILDS WORN STONE STEPS

ID: 6425

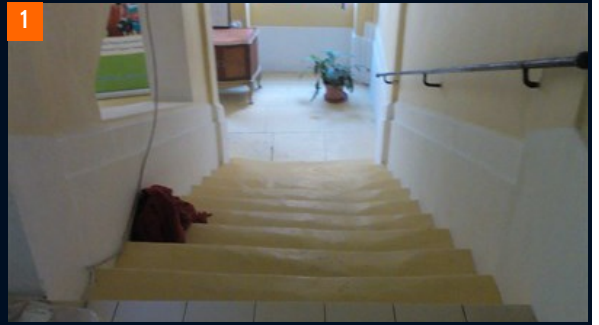
All the stone steps had become badly worn, uneven and sloping towards the front. This was a safety hazard. Due to the construction of the stone steps, it was not possible to repair with other traditional methods.

1. Badly worn stone steps
2. Cleaned and Wooden formers installed
3. Steps filled up and leveled with Belzona 4111
4. Finished Job
