# BELZONA REPAIRS A RESTAURANT ROOF

ID: 6427

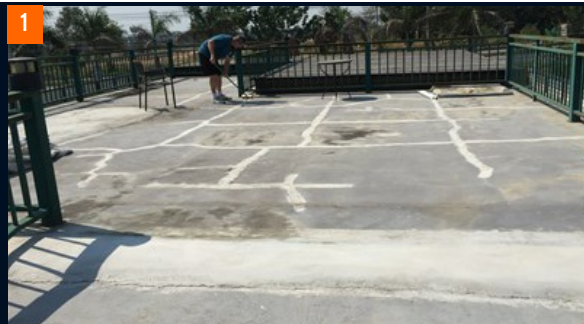
1. Surface Preparation
2. Applying Belzona 3911 (PSC Surface Conditioner)
3. Application of Belzona 9311 Reinforcement Sheet wetted out with Belzona 3111
4. Complete application

The application was carried out in accordance with Belzona System Leaflet RPA-1. The area was made clean, firm and dry prior to application. Problem areas were masked off and Belzona 3911 was applied. Once touch dry, Belzona 9311 Reinforcement Sheet wetted out with Belzona 3111 was applied. Finally, a top coat of Belzona 3111 was applied to complete the system.
