# GASSIFIER MIXER BLADES PROTECTED WITH BELZONA

ID: 643

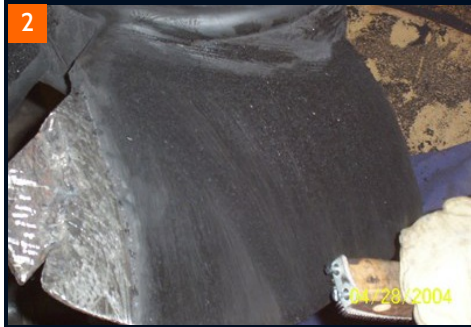
The original rubber coating failed. The leading edge of the steel wore away and large chunks of steel were missing. This decreased the efficiency of the unit.

1. Damaged Gasifier mixer blade leading edge missing
2. New leading edge welded and rubber being prepared
3. Application of Belzona 2121
4. Finished application
