# RESEATING PIN BUSH WITH BELZONA ON CATERPILLAR 980 LOADER

ID: 6432

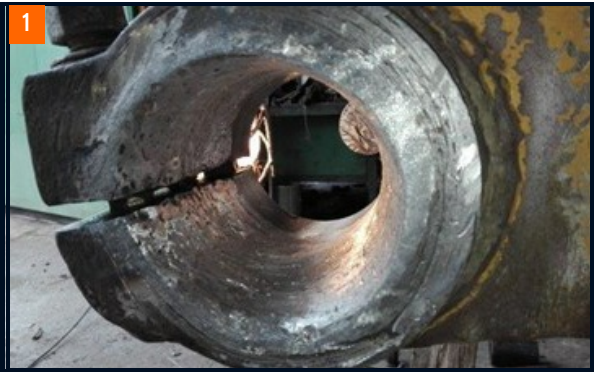
Lack of lubrication had caused abrasion in the bush housing, which led to a diameter increase of 30 mm from the original dimension. This meant a loose fitting bucket pin and unstable use of the equipment.

1. Damaged pin bush housing 2. New bushing installed with Belzona 1111 3. A dummy shaft was used to locate the bushing 4. View of Caterpillar 980 machine

Application was carried out in accordance with Belzona Know-How System leaflet MPT-8. The surface was prepared by grinding and a new bush was bonded into place using Belzona 1111. Other bushing was in a good condition. In order to ensure the bushes were in correct alignment a dummy shaft was used to locate the bushing.
