# BELZONA SECURES TOWER BLOCK

ID: 6436

## PROBLEM

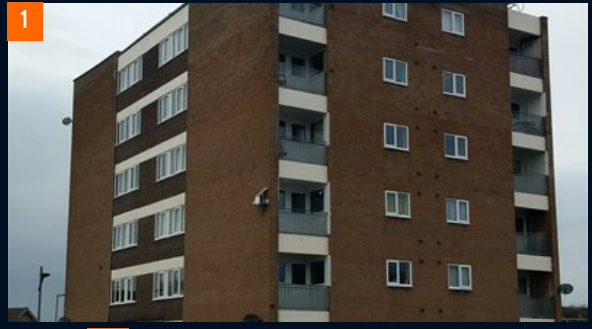
1. Overview of completed work.
2. Typical damage.
3. Belzona 4141 Application in progress.
4. Panel completed after coating with Belzona 5151

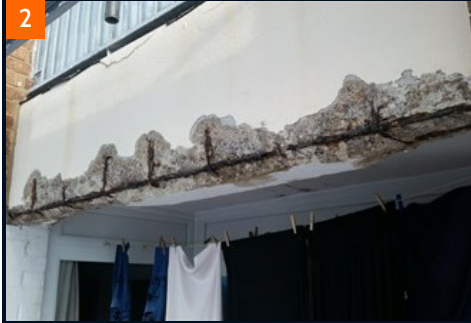
Carbonation of the concrete had caused severe spalling threatening the structure of the balconies and creating a risk of falling debris.
