# BELZONA RESTORES CENTURY-OLD SHIP

ID: 6438

HMS Caroline, a ship owned by the National Museum of the Royal Navy, was undergoing a hull refurbishment in dry dock at Harland and Wolff in Belfast.

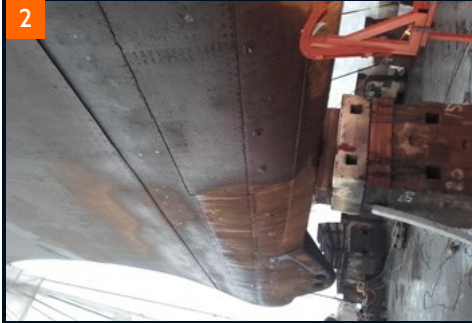
Numerous compartments, fuel tanks and storage areas below the waterline had been taking on water. Welding was limited to areas of the hull that had no leaks, and that were robust enough to withstand hot works. The client was looking for a long-term repair solution, capable of bonding to a poor substrate and with rapid cure times as the dry dock was already booked for another ship repair.

1. HMS Caroline in dry dock
2. Hull in need of leak sealing
3. Cold-applied, fast-curing solution administered
4. Hull after repairs and coating

The application was carried out in accordance with Belzona System Leaflet SOS-1. Due to the size of the project and the short working window, a team of Mixers, Runners and Applicators were utilised. Belzona 1111 was firstly used to fill in badly corroded areas. The poor substrate condition in some areas required a surface-tolerant solution, therefore, Belzona 1212 was used in these.
