# BELZONA RECLAIMS DAMAGED BOWLING ALLEY SIDEPLATE

ID: 645

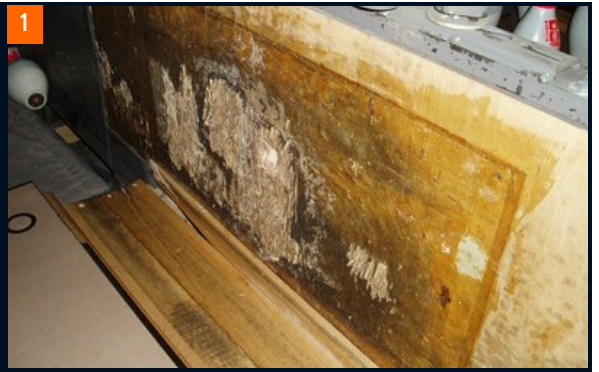
This damage if not repaired would damage customer bowling balls and lead to loss of sanctioning and income.

Damaged side plate on the pin deck

1. Damaged hardwood slab, 3/4-inch deep
2. First layer of Belzona 8111 applied
3. Final layer of Belzona 8111 after sanding
4. Kick plate reinstalled over damaged area

The method used was similar to rebuilding pitting corrosion on vertical vessel walls, a modified Belzona Know-How System Leaflet TCC-5.

Belzona 8111 (Mouldable Wood)
