# BELZONA LINES NEW BUILD DESALTER WITH BELZONA 1391T

ID: 6454

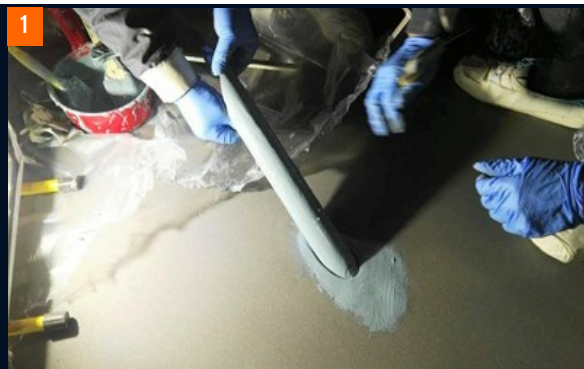
- 1.Nozzle Insert
- 2.2nd Coating
- 3.Spark Test
- 4.Final

Application was carried out in accordance with Belzona Know-How System Leaflet TCC-5 and TCC-16b . Preformed nozzle inserts were created and bonded into small diameter nozzles to ensure continuity of protection.
