# BELZONA REPAIRS GTG SYNTHETIC LUBE OIL TANKS

ID: 6457

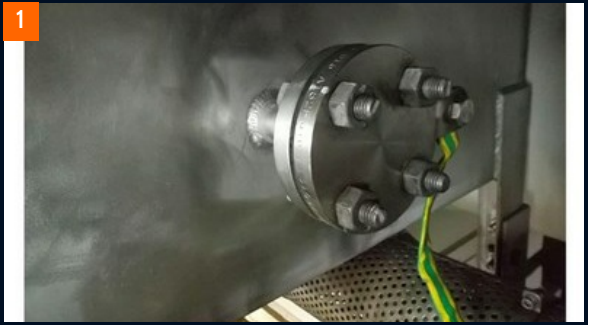
A crack was found on a Stainless Steel LO tank on one of the gas turbine generator sets. The crack ran approximately 5-10cm around a 1" nozzle.

1. Surface preparation
2. Belzona 1511 being applied to doubler plates
3. Belzona 1391T being Injected in-between doubler plates and tank
4. Doubler plates bonded onto tank

Application was carried out in accordance with Belzona Know-How system Leaflet TCC-1 and following a client approved Method Statement. A doubler plate was fabricated and sealed in place with Belzona 1511 before Belzona 1391T was injected to cold bond and seal the doubler plate to the tank. This sealed the leak and added extra strength to the tank.
