# BELZONA CURES DAMP WALLS

ID: 6458

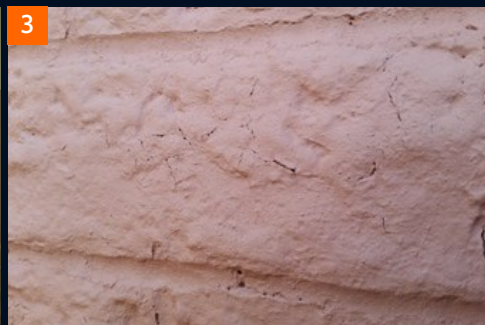
Recurring damp was causing damage to the interior and subsequent remedial works. Several solutions had been tried in the past but they had failed to solve the problem. The cause of the damp was not obvious and after seeking professional advice from several sources, the customer was advised that driving rain was the most likely cause.

1. House before application
2. Damage to interior
3. Ineffective existing coating
4. Completed application

It was found that the previous coating had numerous defects that allowed water to become trapped, causing the damp. The flexibility and microporous properties of Belzona 5151 allow moisture to escape while preventing further ingress. Since applying the Belzona 5151 the client has not had any problems.
