# BELZONA REPAIRS AND PROTECTS SCREW CONVEYOR

ID: 6459

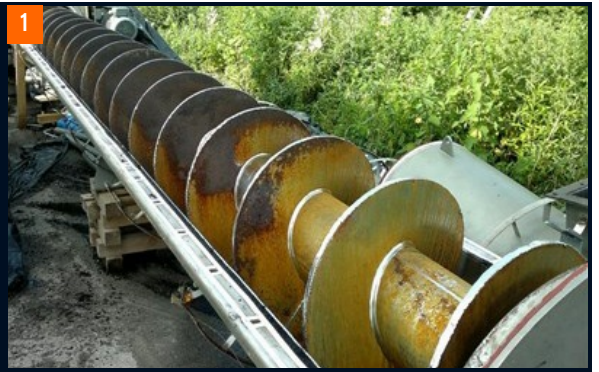
The new screw conveyor suffered surprisingly fast wear by erosion and bi-metallic corrosion. The shaft of the screw conveyor had been topped with a stainless steel sheet to protect it from corrosion. However, after less than a year of operation the steel was worn from the surface of the shaft. In addition to the aggression of chemical sludge, it reaches a very high temperature of approx. 120 degrees Celsius.

- 1.Screw conveyor before application
- 2.Visible effects of galvanic corrosion
- 3.Application of Belzona 9811 and Belzona 1511
- 4.View after grouting with Belzona 1813
