# BELZONA REPAIR TO GAS BREAKER

ID: 647

Aluminum gas breaker at substation outside natural gas powerplant

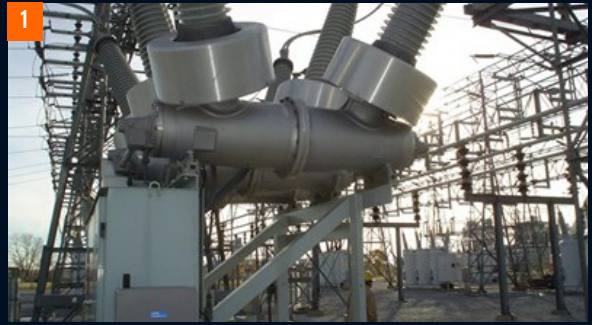
Gas was quickly escaping and the utility had to send maintenance crews to refill the breaker every 2 weeks so that it would not lock-out.

1. The breaker leaking gas
2. Soapy water sprayed to detect location of leak
3. Area prepared for application by grinding
4. Completed repair soaked in soapy water to ensure no leaks
