# MUFF COUPLING REPAIR WITH BELZONA

ID: 648

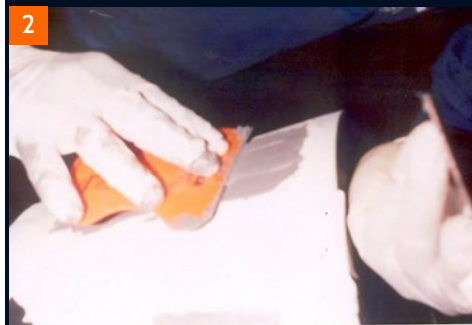
Scratches on inner and outer surfaces of coupling.

1. Scratches on the inner part of the Muff Coupling
2. Filling the scratches with Belzona 1111
3. Belzona 1111 applied to the coupling
4. Application completed

Application was carried out using a modification of Belzona Know-How System Leaflet MPT-13. The scratches were rebuilt then the surface was finished to size.
